A System Safety Success: The Midcourse Space Experiment

Joyce A. McDevitt and Clayton A. Smith
Futron Corporation

SPIRIT III FAILURE

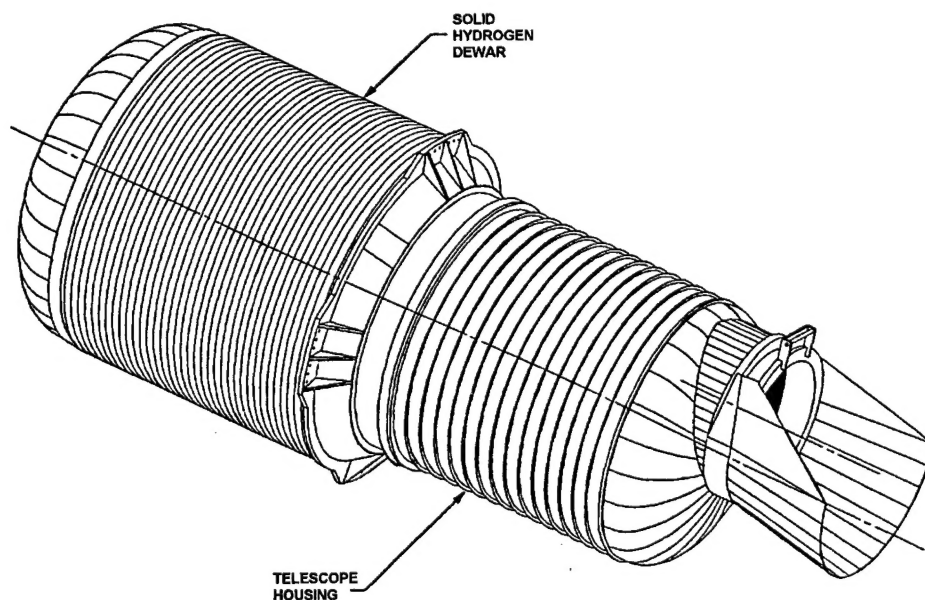
Figure 2. SPIRIT III Exterior

Figures 2 and 3 show the exterior of the SPIRIT III assembly and a schematic of this configuration. The main part of the cryogen system is the dewar. The dewar is a 40½-inch diameter cylindrical tank with domed ends. The tank is partially filled with an open-cell 1.5 to 3.0 percent dense aluminum foam. The foam prevents movement of the solid hydrogen within the tank during spacecraft slew operations and acted to greatly reduce temperature differentials in the tank as the hydrogen sublimates away from the tank wall. To reduce parasitic heat loads into the tank, the cryostat features two vapor-cooled shields, and on orbit, a passively cooled (200°K) external vacuum shell. Throughout ground processing, the vacuum shell remains at ambient temperature. The cryostat provides temperature sensors to monitor the status of the cryogen.
